CHOWDER TALK

OCTOBER 15, 2013

Murrells Inlet Volunteer Water Monitoring Program

Murrells Inlet Watershed-based Plan

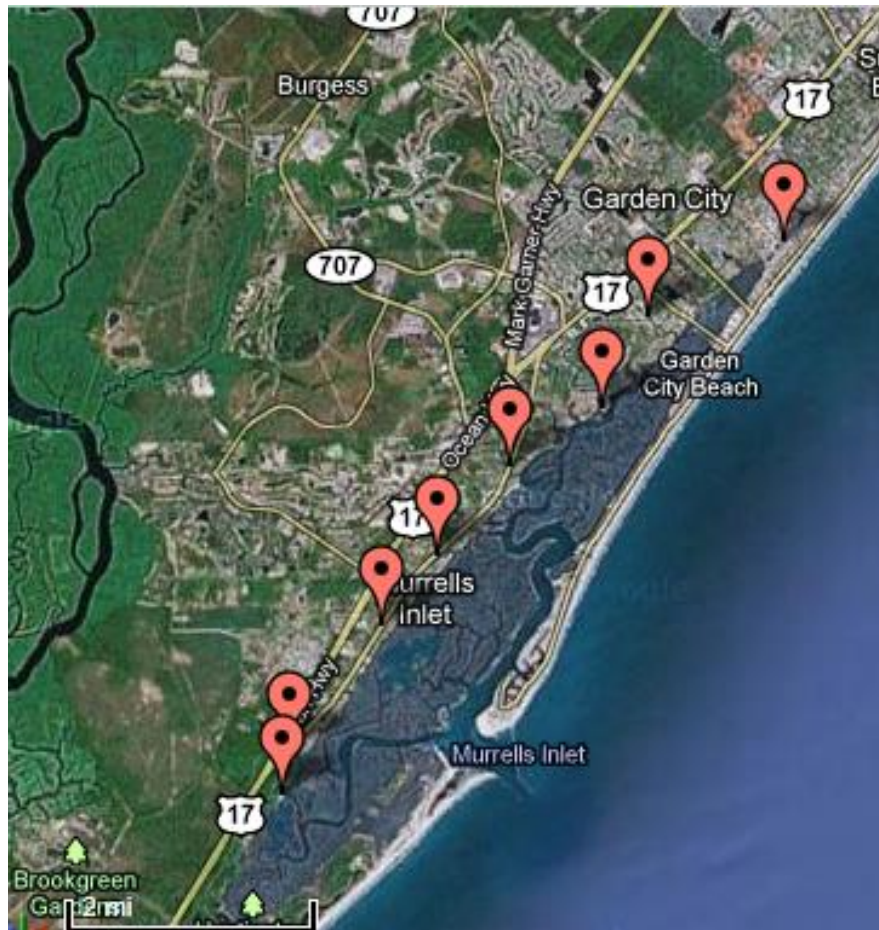
Eight Testing Site Locations

1. Woodland Pond
2. Point Drive Canal
3. Rum Gully Creek
4. Marina Colony Pond
5. Harrelson's creek
6. Boat House Run creek
7. Bike Bridge creek
8. Oyster Landing Beach

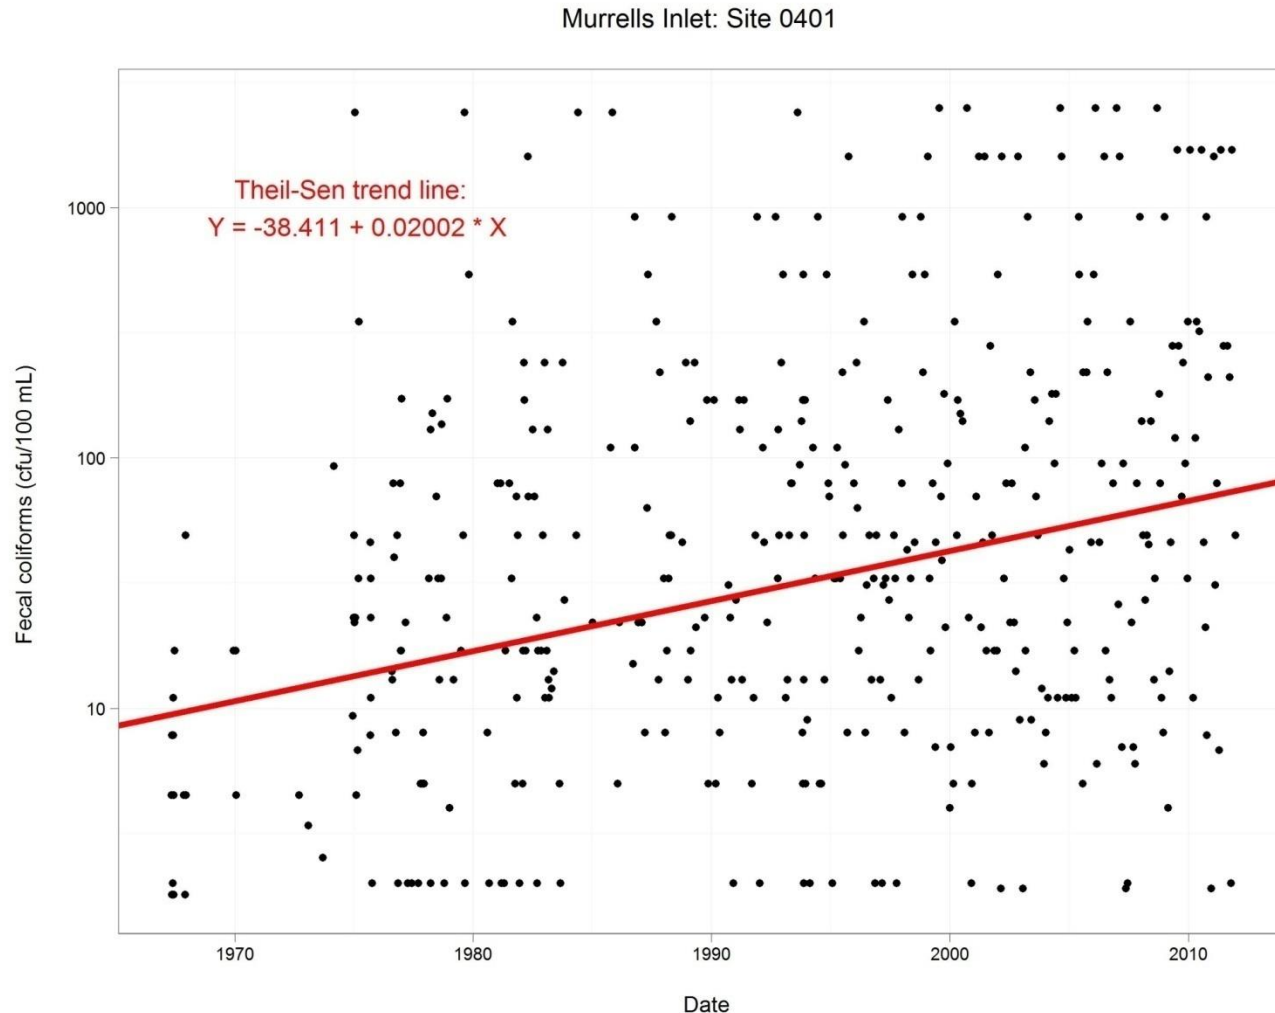
Data Variability

Fecal coliform measurements
have been highly variable, dating back to the 1960's.

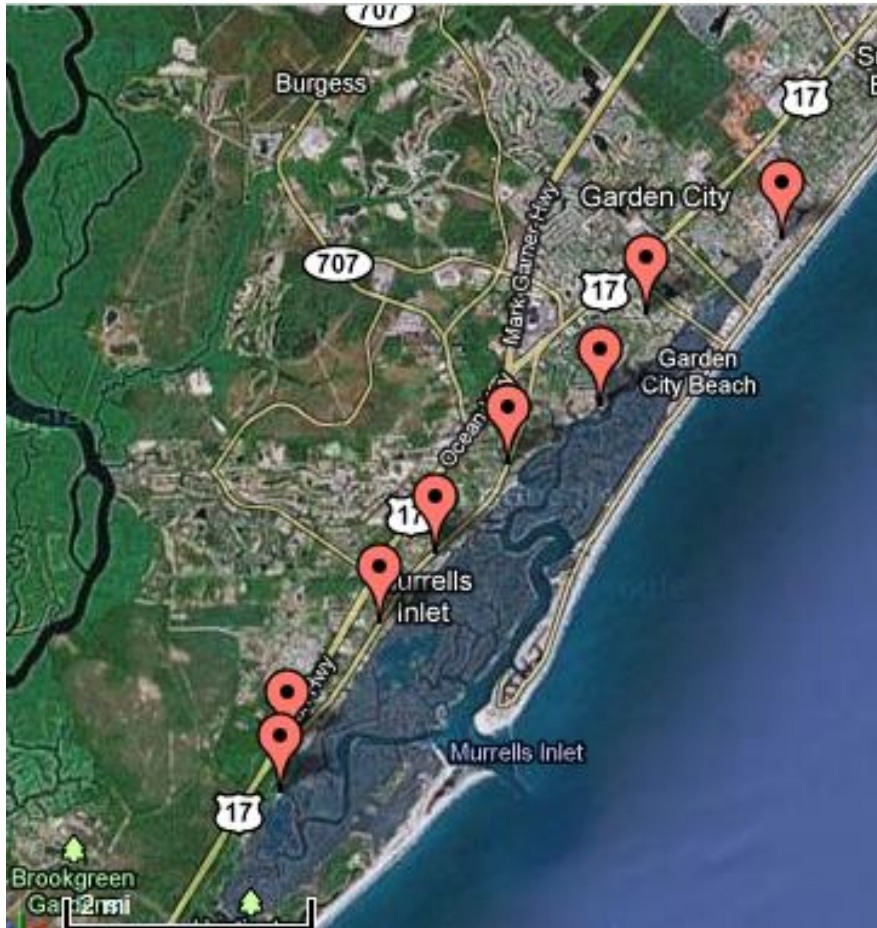
Site Findings

1. Woodland Pond
2. Point Drive Canal
3. Rum Gully Creek
4. Marina Colony Pond
5. Harrelson's creek
6. Boat House Run creek
7. Bike Bridge creek
8. Oyster Landing Beach

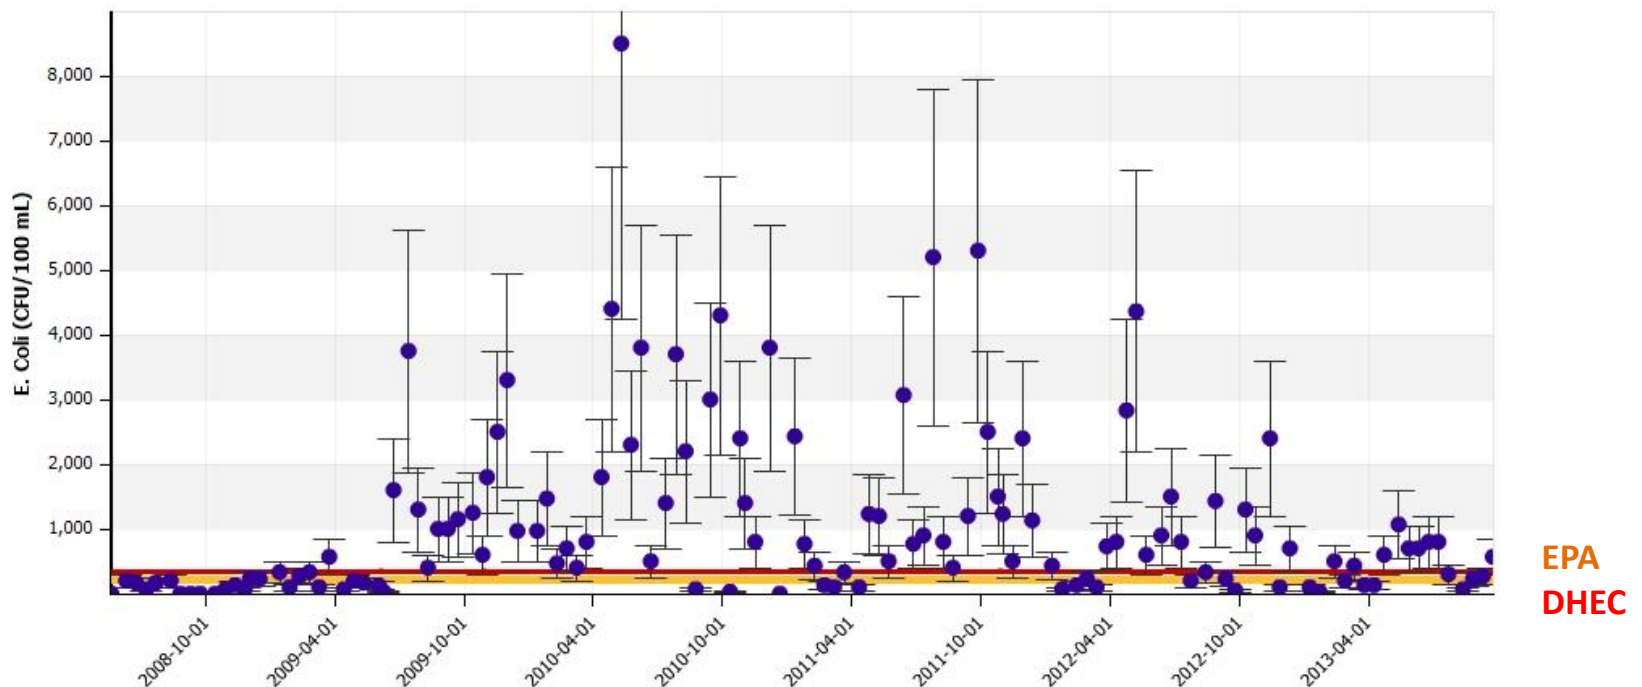
Monitoring Site	2011	2012	2013
Woodland Drive Pond (partly saline)	<ul style="list-style-type: none"> • High Bacteria • Low Dissolved Oxygen (DO) 	<ul style="list-style-type: none"> • same 	<ul style="list-style-type: none"> • same

E. Coli (CFU/100 mL) values collected between May 20, 2008 and September 24, 2013

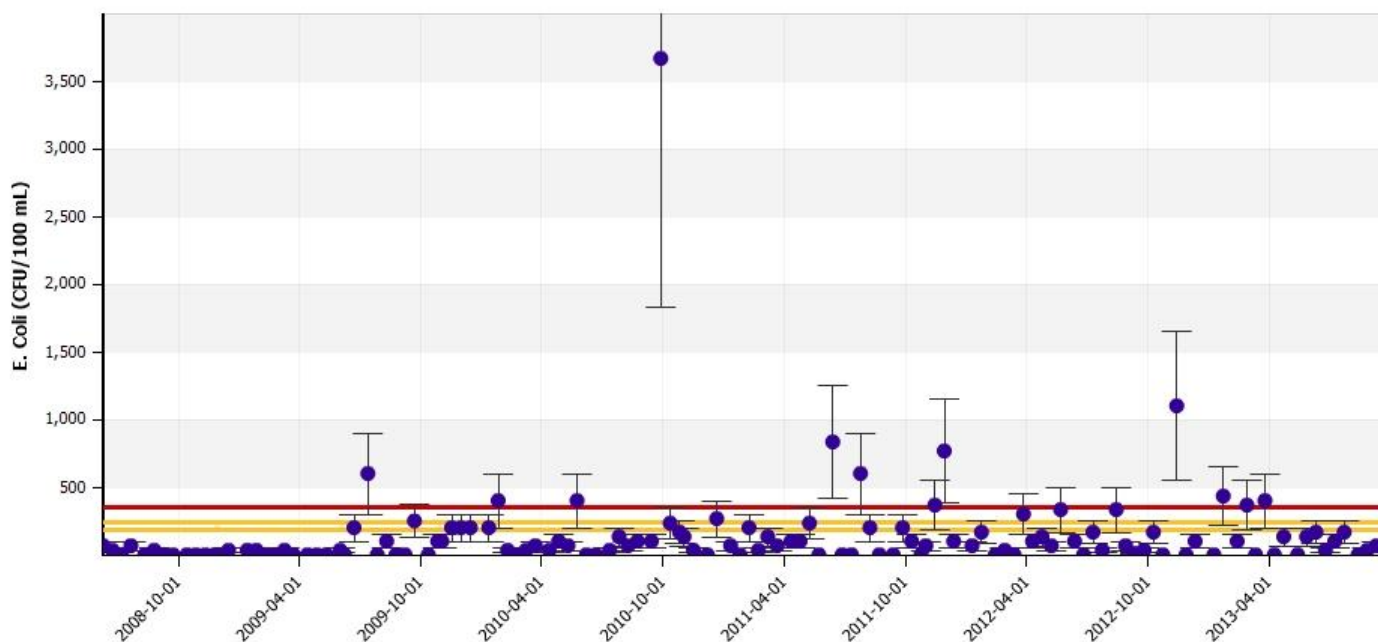
Monitoring Site	2011	2012	2013
Point Drive Canal	<ul style="list-style-type: none">• Low pH (acidic)• Low Dissolved Oxygen (DO)	<ul style="list-style-type: none">• same	<ul style="list-style-type: none">• Low Dissolved Oxygen (DO)

E. Coli (CFU/100 mL) values collected between May 20, 2008 and September 24, 2013

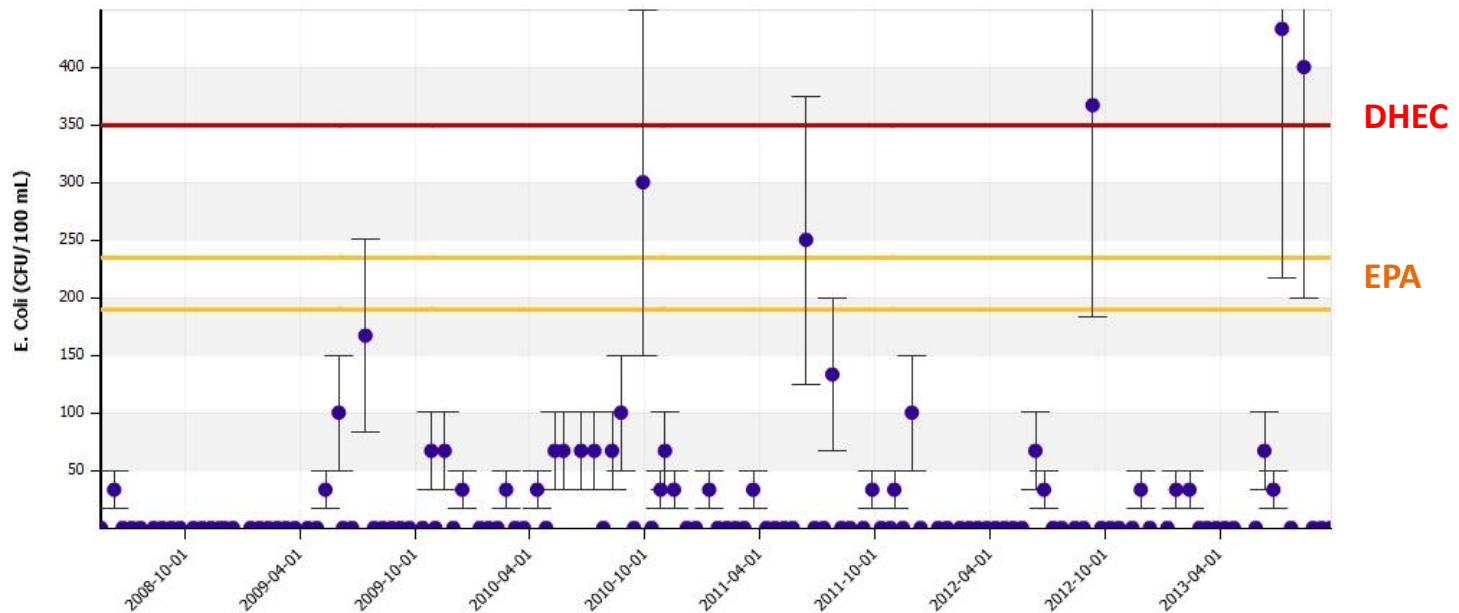
Monitoring Site	2011	2012	2013
Rum Gully Creek (saline)	<ul style="list-style-type: none"> Low Dissolved Oxygen (DO) 	<ul style="list-style-type: none"> same 	<ul style="list-style-type: none"> Low Dissolved Oxygen (DO) High turbidity

E. Coli (CFU/100 mL) values collected between May 20, 2008 and September 24, 2013

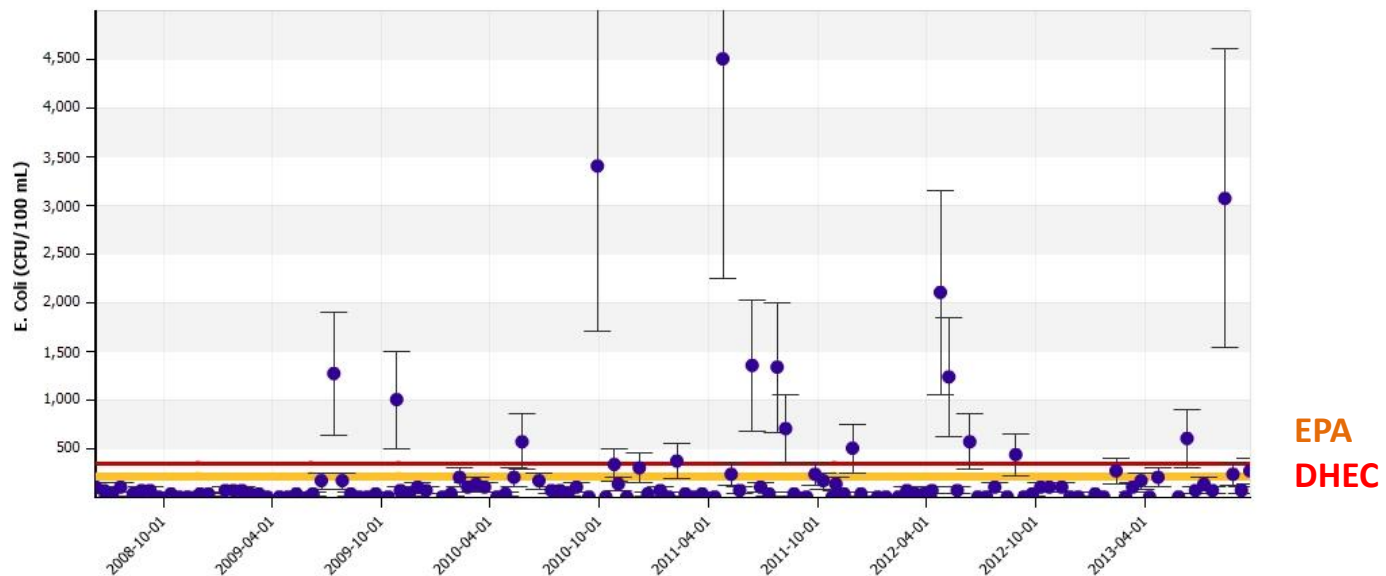
Monitoring Site	2011	2012	2013
Marina Colony Pond	<ul style="list-style-type: none"> Very low Dissolved Oxygen (DO) Low pH (acidic) 	<ul style="list-style-type: none"> Very low Dissolved Oxygen (DO) High ammonia Low pH (acidic) 	<ul style="list-style-type: none"> Occasionally high bacteria Very low Dissolved Oxygen (DO) High ammonia

E. Coli (CFU/100 mL) values collected between May 20, 2008 and September 24, 2013

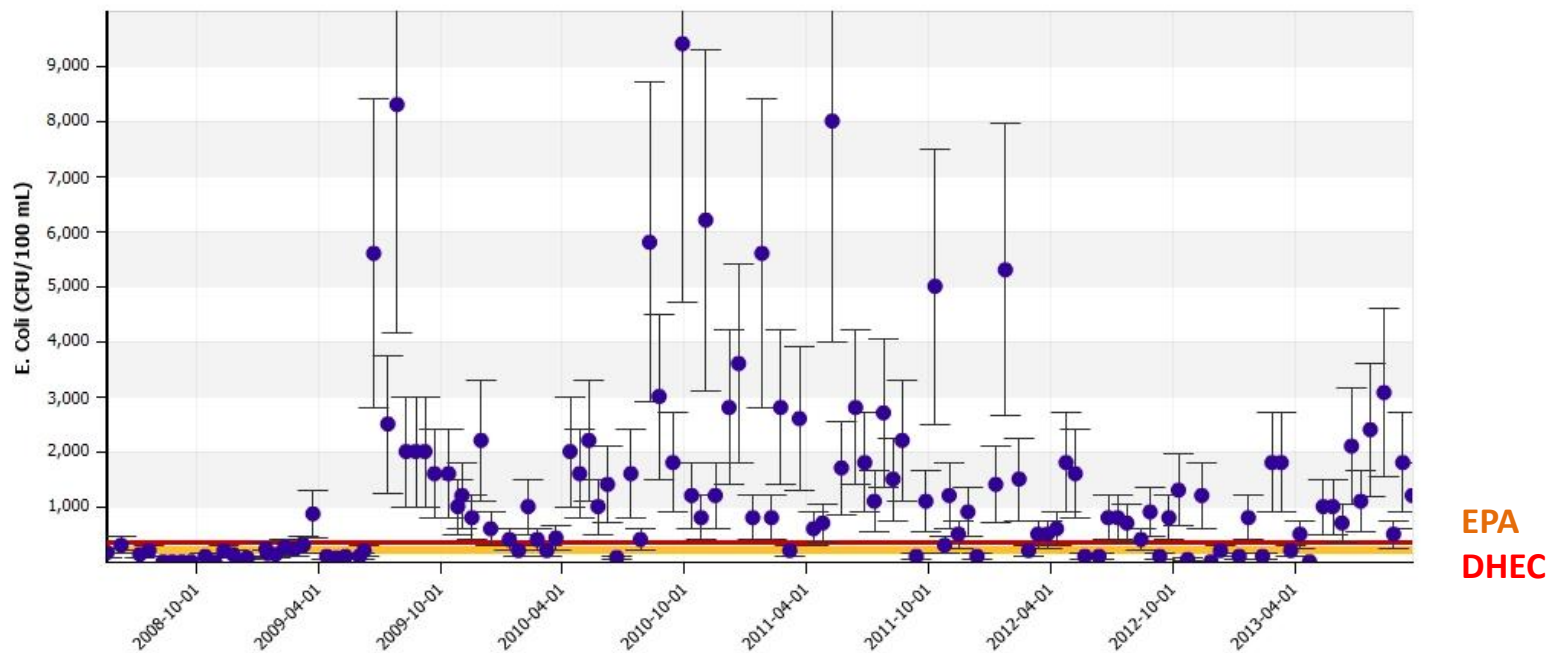
Vaux Hall Creek

Monitoring Site	2011	2012	2013
Vaux Hall creek (partly saline)	<ul style="list-style-type: none"> • Very high bacteria • Low Dissolved Oxygen (DO) • High ammonia 	<ul style="list-style-type: none"> • same 	<ul style="list-style-type: none"> • same

E. Coli (CFU/100 mL) values collected between May 20, 2008 and September 24, 2013

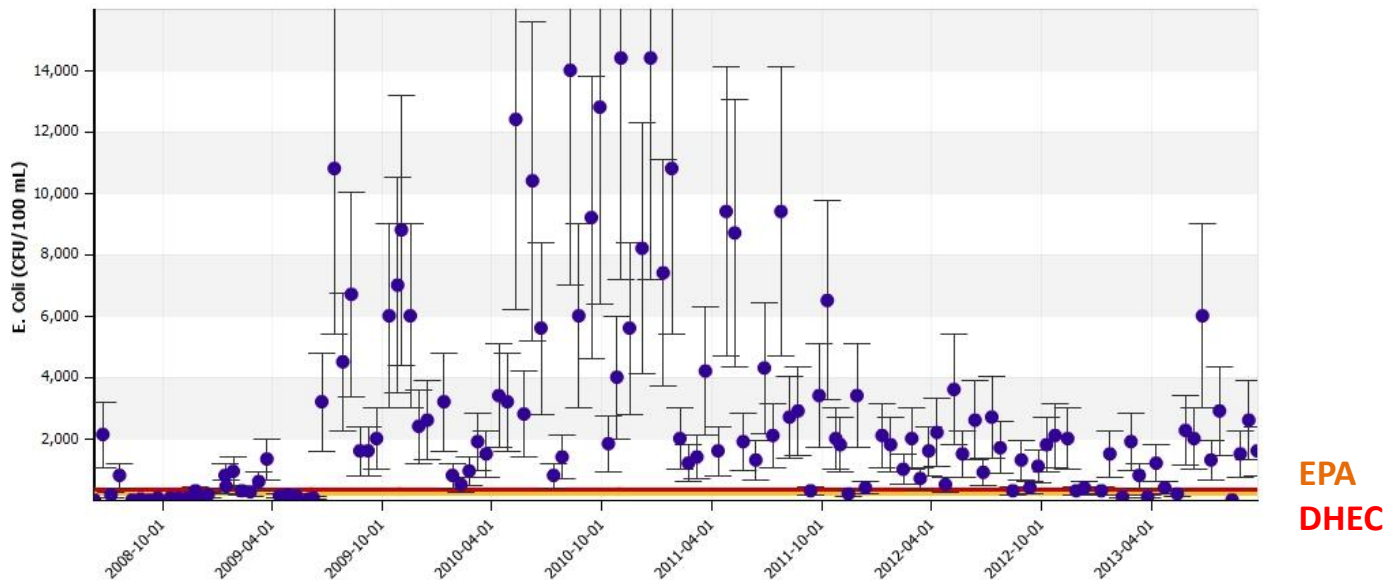
Boathouse Run Creek

Monitoring Site	2011	2012	2013
Boathouse Run creek (partly saline)	<ul style="list-style-type: none"> • Very high bacteria • Low Dissolved Oxygen (DO) • High ammonia 	<ul style="list-style-type: none"> • same 	<ul style="list-style-type: none"> • Very high bacteria • Low Dissolved Oxygen (DO) • Very high ammonia

E. Coli (CFU/100 mL) values collected between May 20, 2008 and September 24, 2013

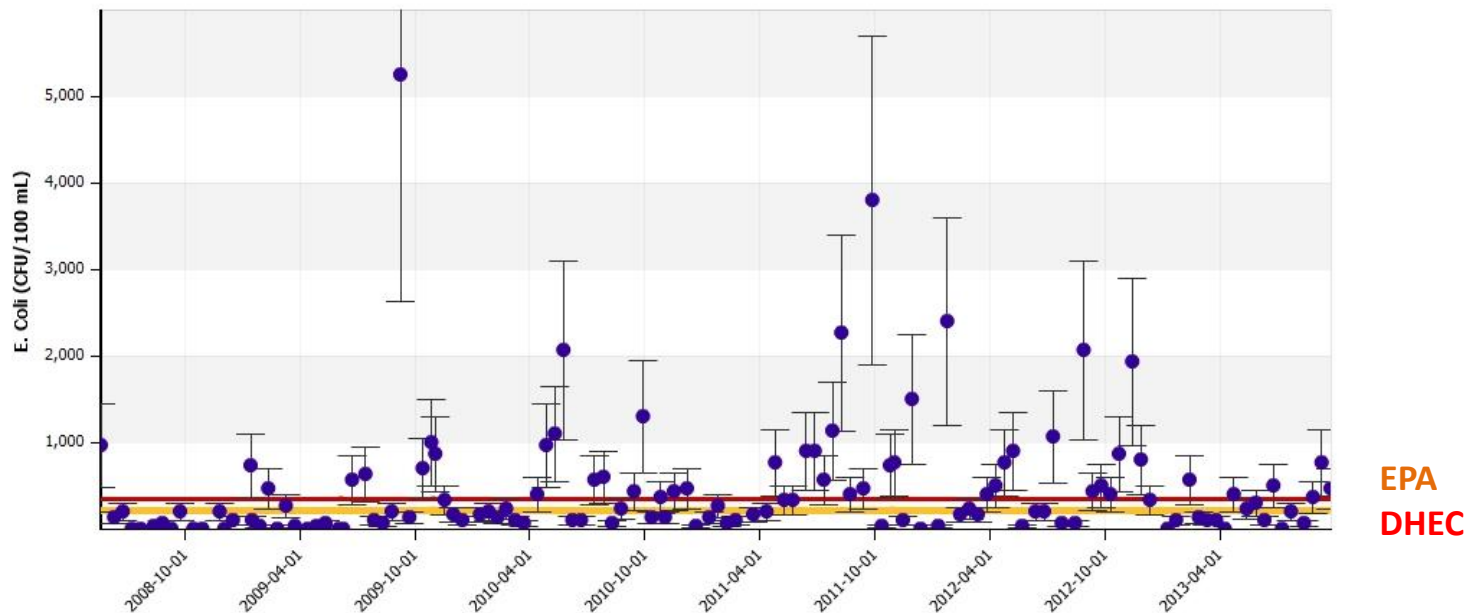
Bike Bridge Creek

Monitoring Site	2011	2012	2013
Bike Bridge creek (partly saline)	<ul style="list-style-type: none"> • High bacteria • Low Dissolved Oxygen (DO) • Very high ammonia 	<ul style="list-style-type: none"> • same 	<ul style="list-style-type: none"> • High bacteria • Low Dissolved Oxygen (DO)

E. Coli (CFU/100 mL) values collected between May 20, 2008 and September 24, 2013

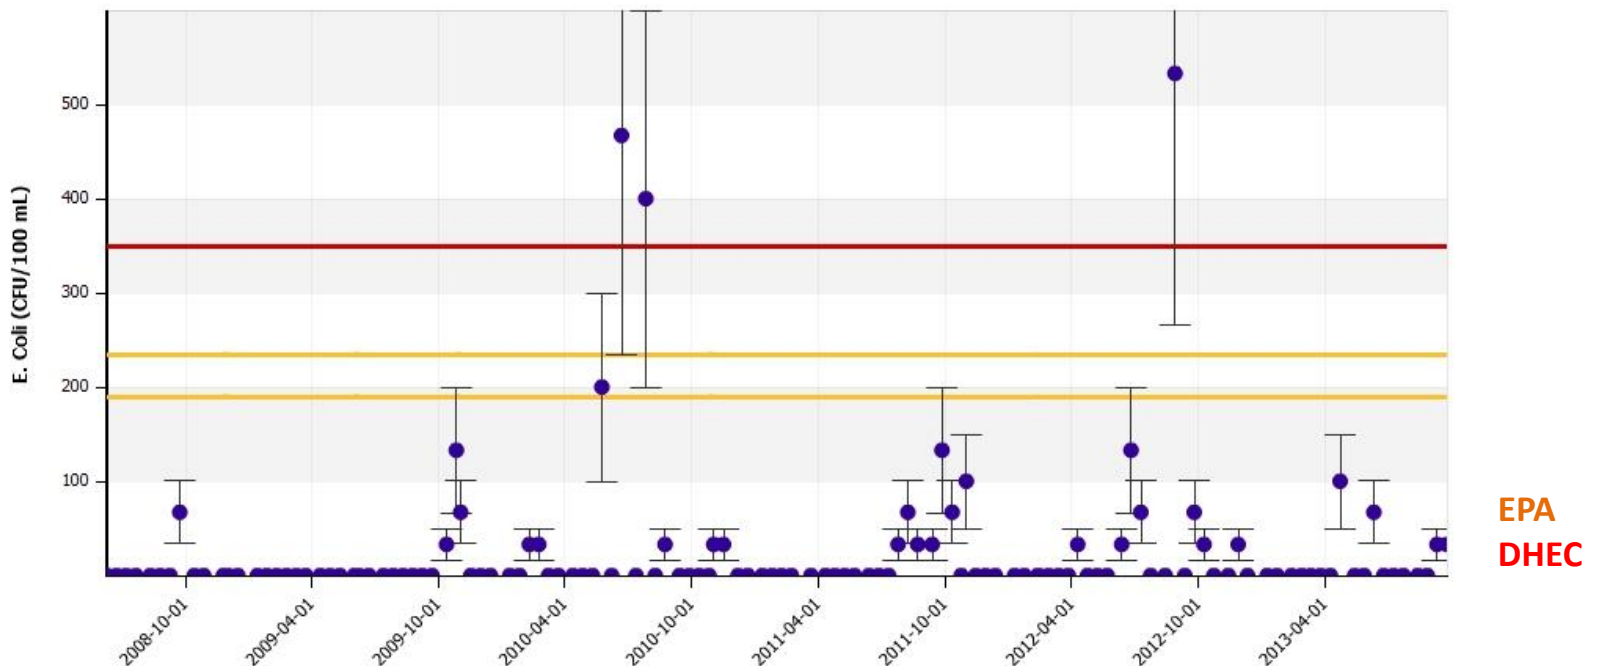
Monitoring Site	2011	2012	2013
Oyster Landing Beach (saline)	<ul style="list-style-type: none"> High turbidity 	<ul style="list-style-type: none"> same 	<ul style="list-style-type: none"> High turbidity Low Dissolved Oxygen (DO) Very high ammonia

E. Coli (CFU/100 mL) values collected between May 20, 2008 and September 24, 2013

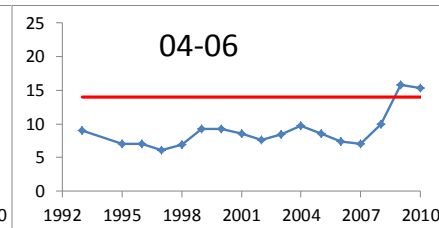
Geomean
time trends

WQS = 14

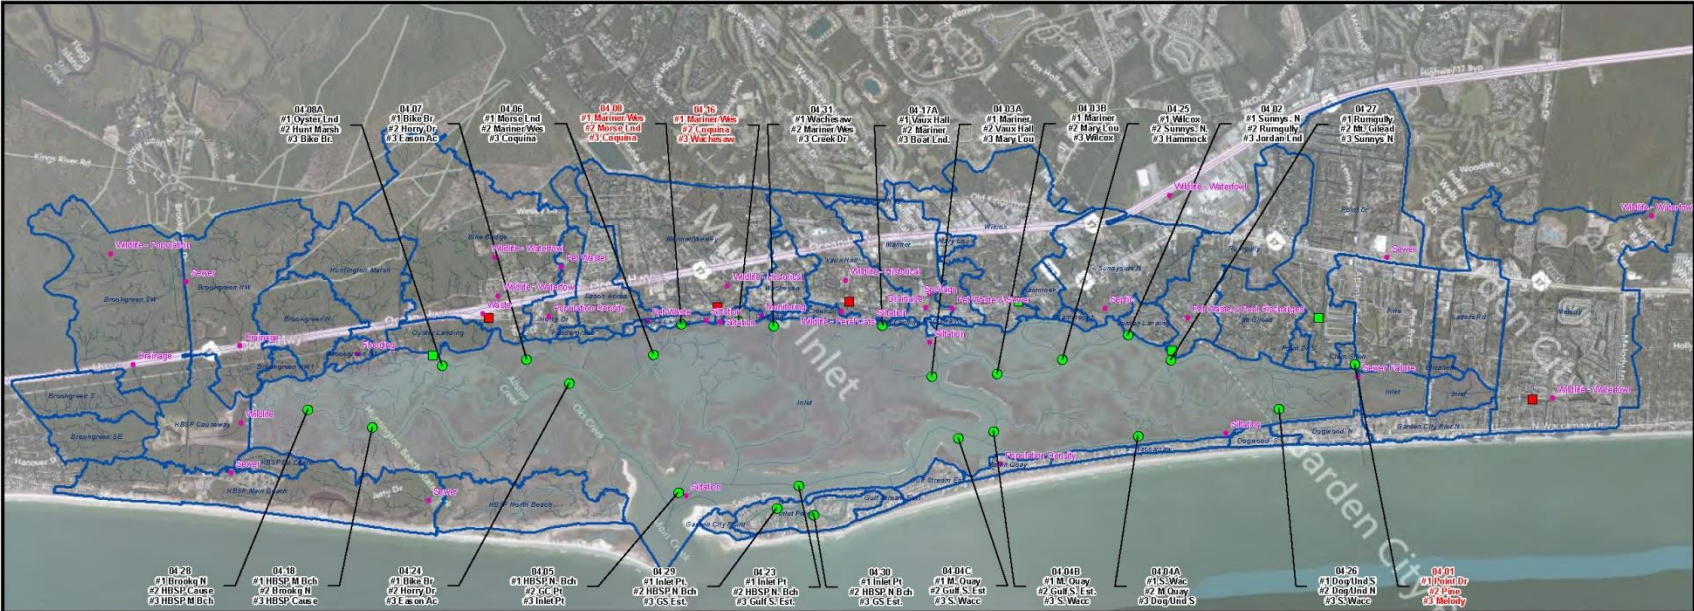
Murrells Inlet Subwatersheds & DHEC Station Status

TABLE C-2 90TH PERCENTILE TRENDS BY MONITORING SITE

Sites	1992-1994	1995-1996	1997-1998	1999-2000	2001-2002	2003-2004	2005-2006	2007-2008	2009-2010	2011	% Over
TIER 1											
1	O	O	O	O	O	O	O	O	O	O	100%
8	O	O	O	O	O	O	O	O	O	O	100%
16	O	O	O	O	O	O	O	O	O	O	100%
TIER 2											
2	O	U	U	O	U	O	O	O	O	O	82%
6	O	U	U	U	U	O	O	U	U	O	65%
26	O	U	U	U	O	O	O	O	O	O	82%
27	O	U	O	U	O	O	O	O	O	O	82%
28	O	U	U	U	U	U	O	O	O	O	35%
TIER 3											
7	O	U	U	U	U	U	U	O	O	O	29%
17A	Monitoring not initiated until this date										56%
08A	U	U	U	U	U	U	U	U	U	U	0%
18	U	U	U	U	U	U	U	U	U	U	12%
31	Monitoring not initiated until this date										33%
32	Monitoring not initiated until this date										0%

NOTES: O= Over 90th Percentile Standard of 43MPN/100ml U= Under 90th Percentile Standard of 43MPN/100ml

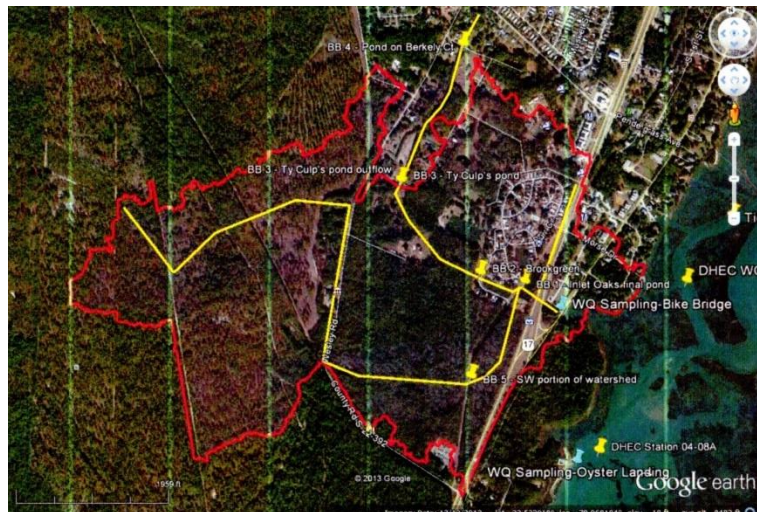
Bike Bridge

Upstream Monitoring
