PLANT SURVIVAL IN THE FLOODPLAIN RESTORATION OF CRABTREE SWAMP, HORRY COUNTY, SC

REFERENCE: *Proceedings of the 2012 South Carolina Water Resources Conference*, held October 10-11, 2012, at the Columbia Metropolitan Convention Center.

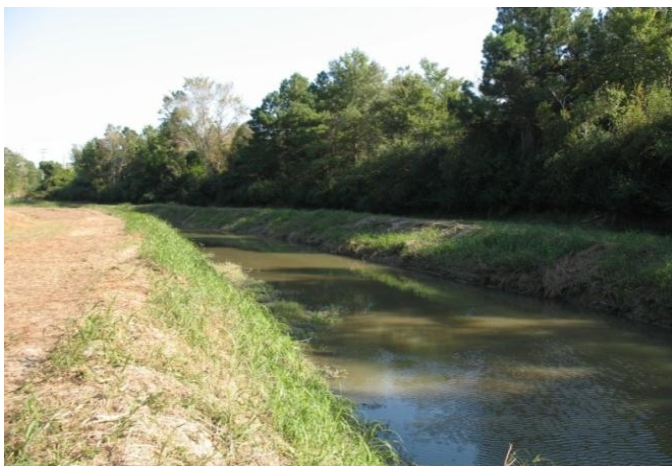
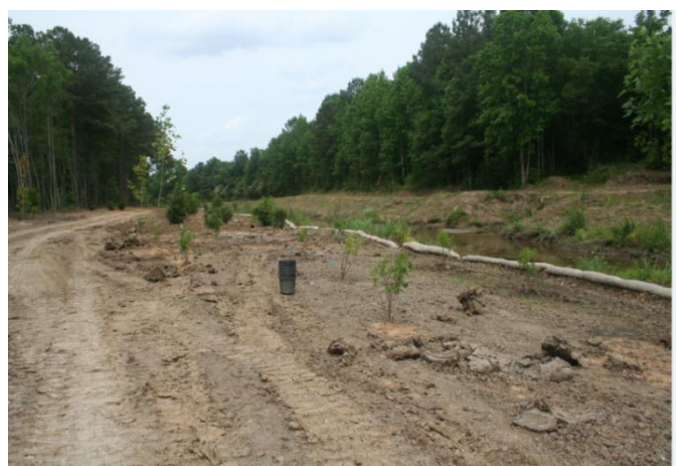
Figure 2. (a) Left hand photograph shows steepened banks of Crabtree Canal prior to restoration. (b) Right-hand photograph shows restored floodplain during planting. Erosion control logs are located at top of bank in the aquatic zone.

In May 2009, construction began at the chosen demonstration site to reconnect the floodplain along a ½-mile segment of one bank of Crabtree Canal (Figures 1 and 2b). A second ½-mile segment is undergoing restoration, 0.3 miles upstream of the first site on the opposite bank.
